A New Bolted Joint Profile, Optimized with FEA, Fixes a Leaking Propane Pump.

John M Schmidt, PE, Oregon

The Issue.

A Vertical Pump (VS6) in Propane loading service (installed 1978) at a Petroleum Refinery.

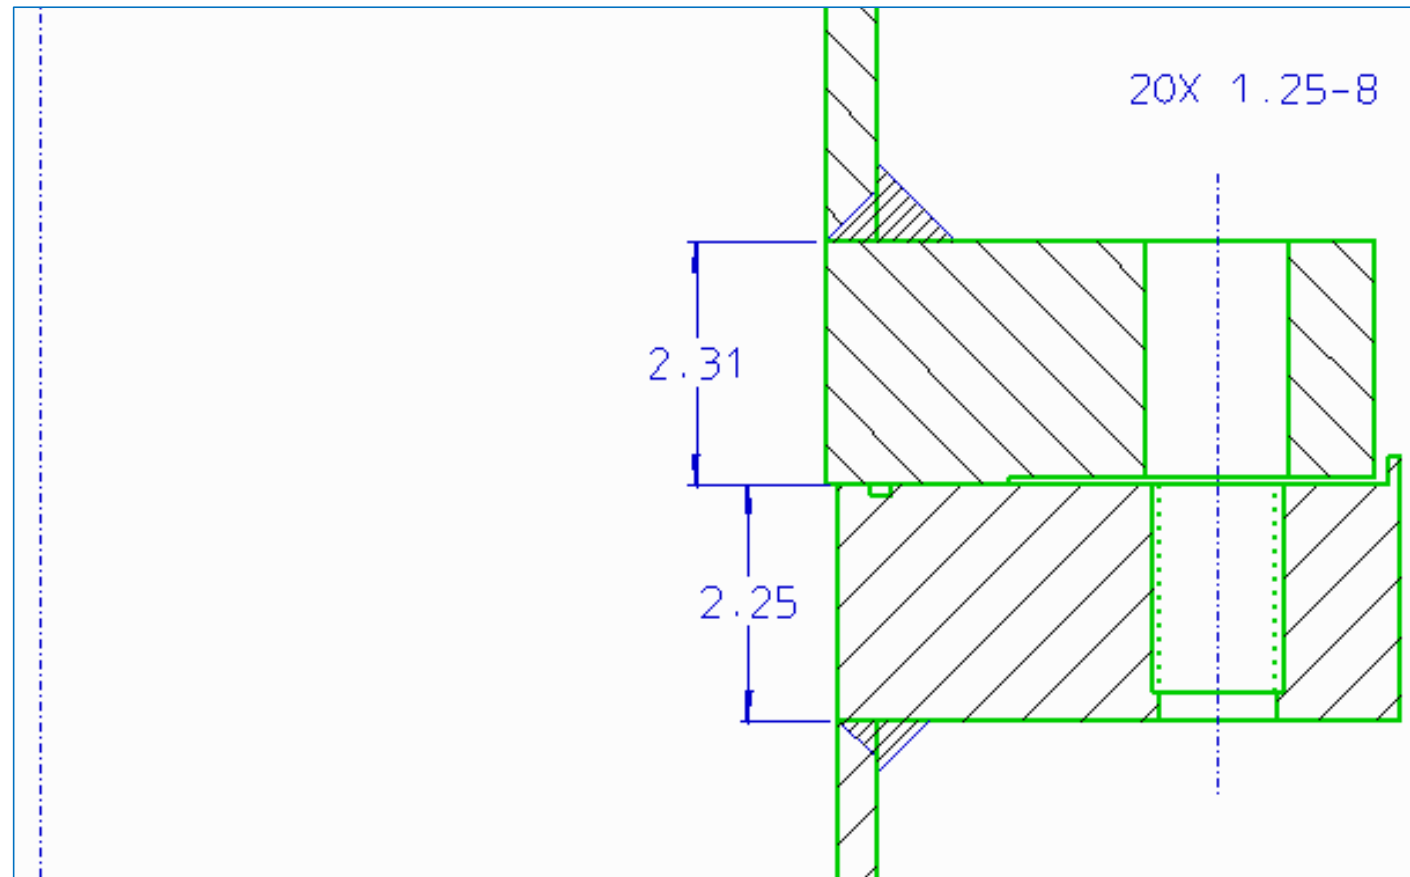
The original design

Upon further inquiry, the reason for the requested upgrade was because the current raised faced joint (with an O-ring) would occasionally leak.

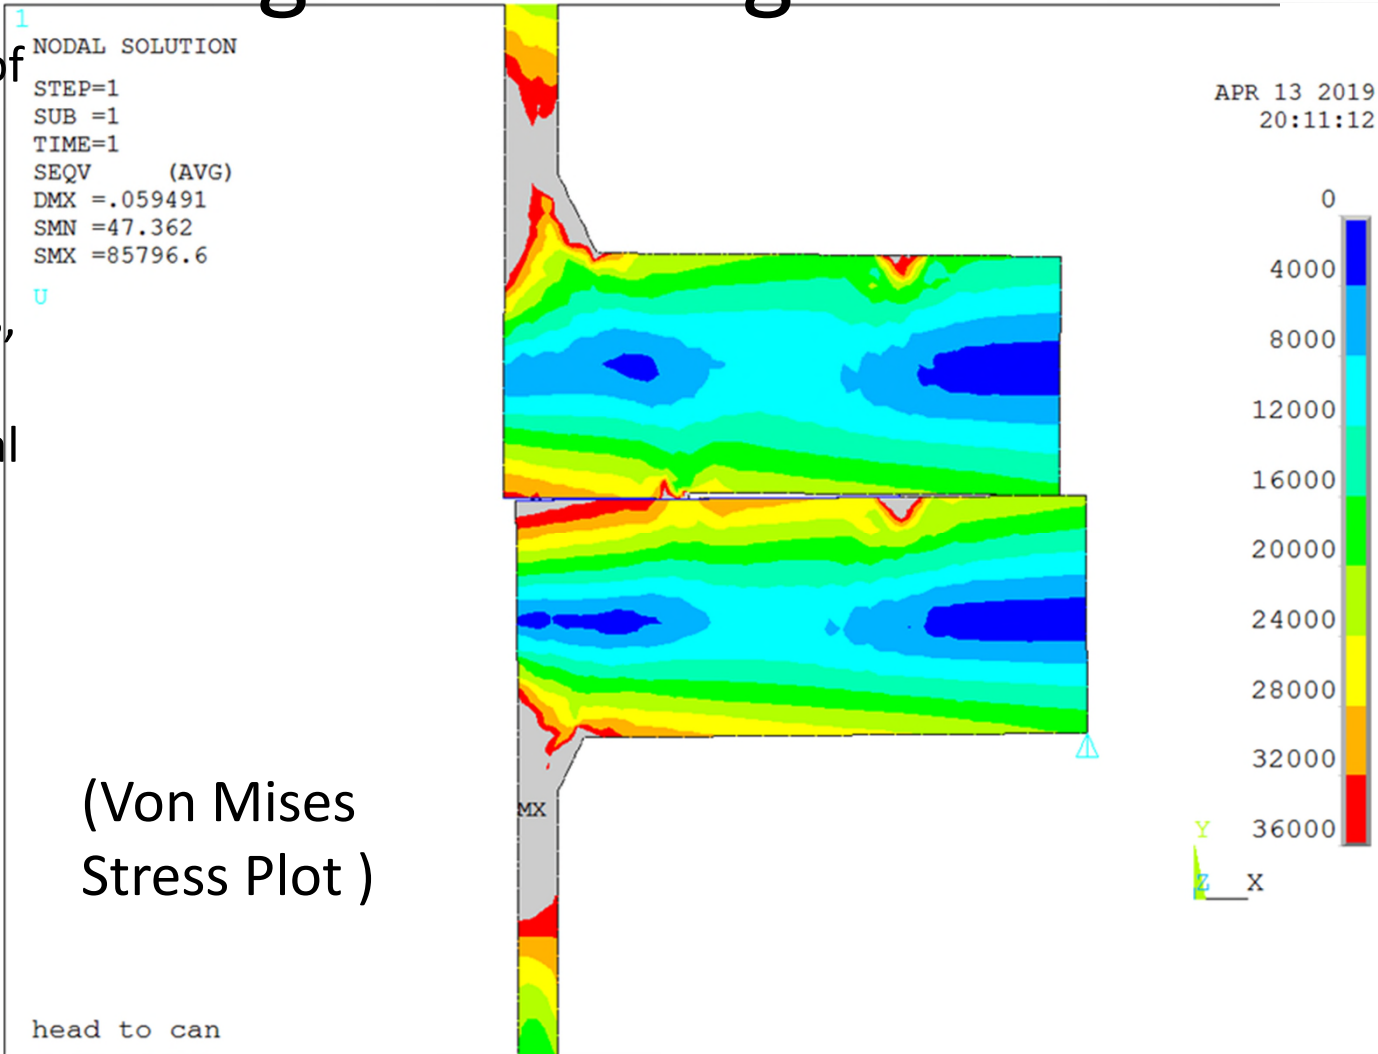
FEA of the original design.

An axisymmetric FEA model of the original circa 1970's design.

Bolt force 0.6e6 lbf (20 bolts, ~ 30% of bolt yield strength, 30,000 lbf each bolt). Internal Pressure: 720 psi.

ISSUE 1: Flange rotation results in exceeding material Yield Strength.

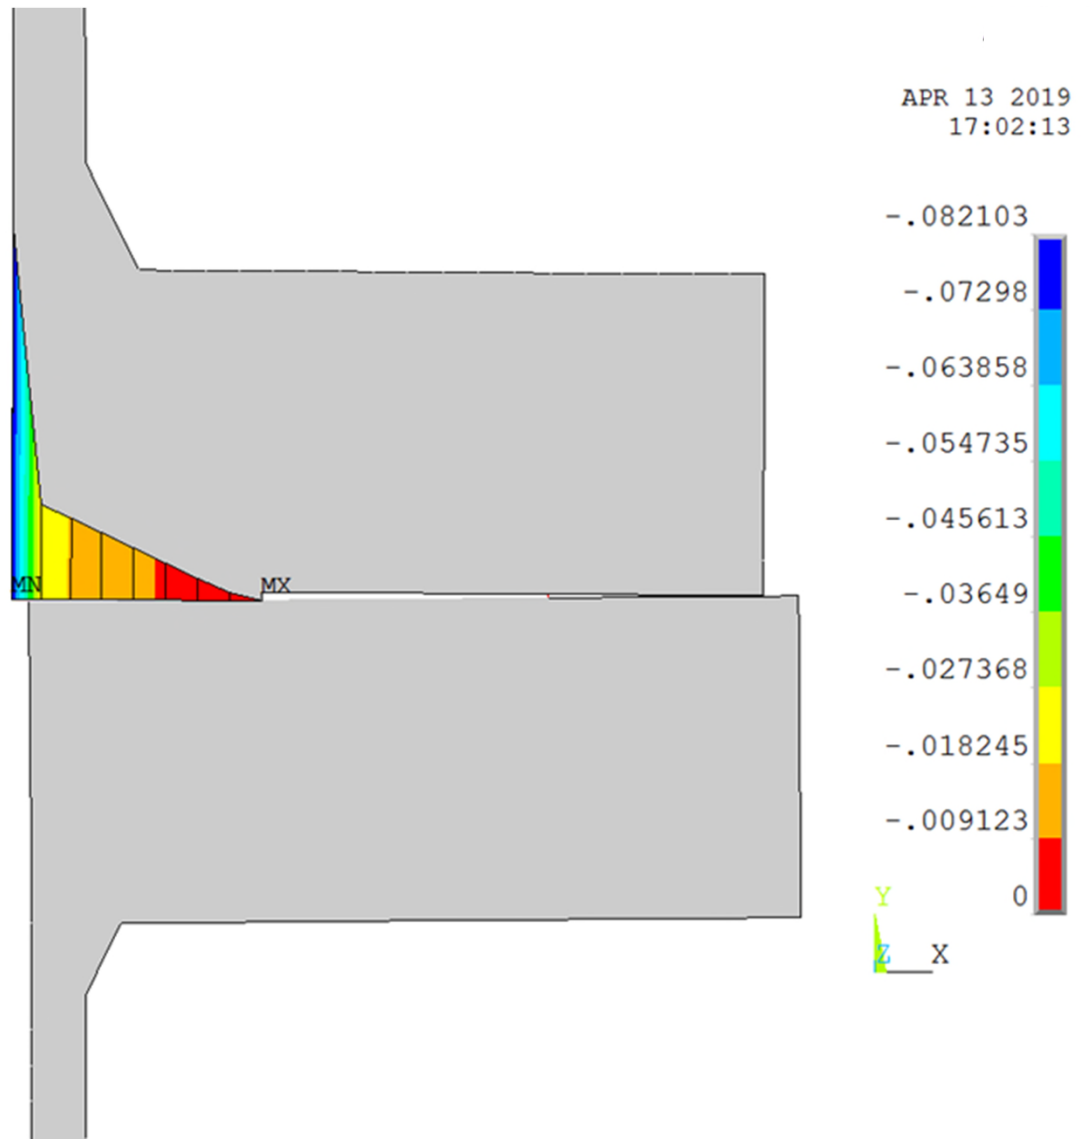
FEA of Original Design.

And ISSUE 2: A gap has opened up at the gasket location (~.018")

Contact
Gap Plot

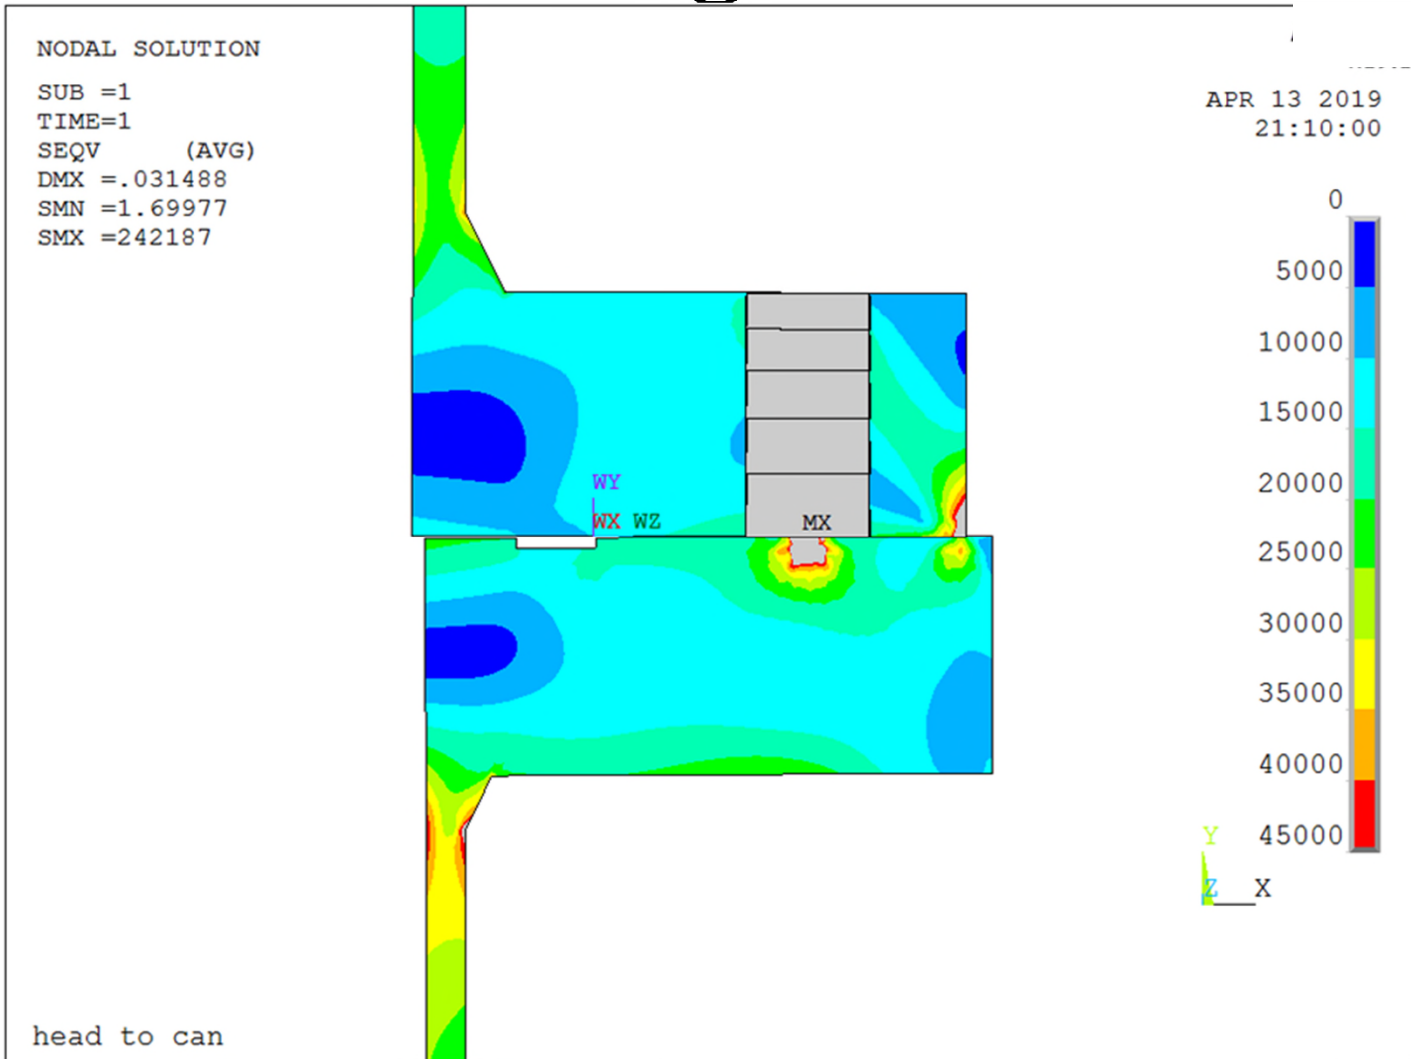
FEA of a Flat Face Design

Try a flat face design with a Spiral Wound gasket.

Hydrotest 1080 psi.

Von Mises Stress Plot ->>
(looks pretty good, but...)

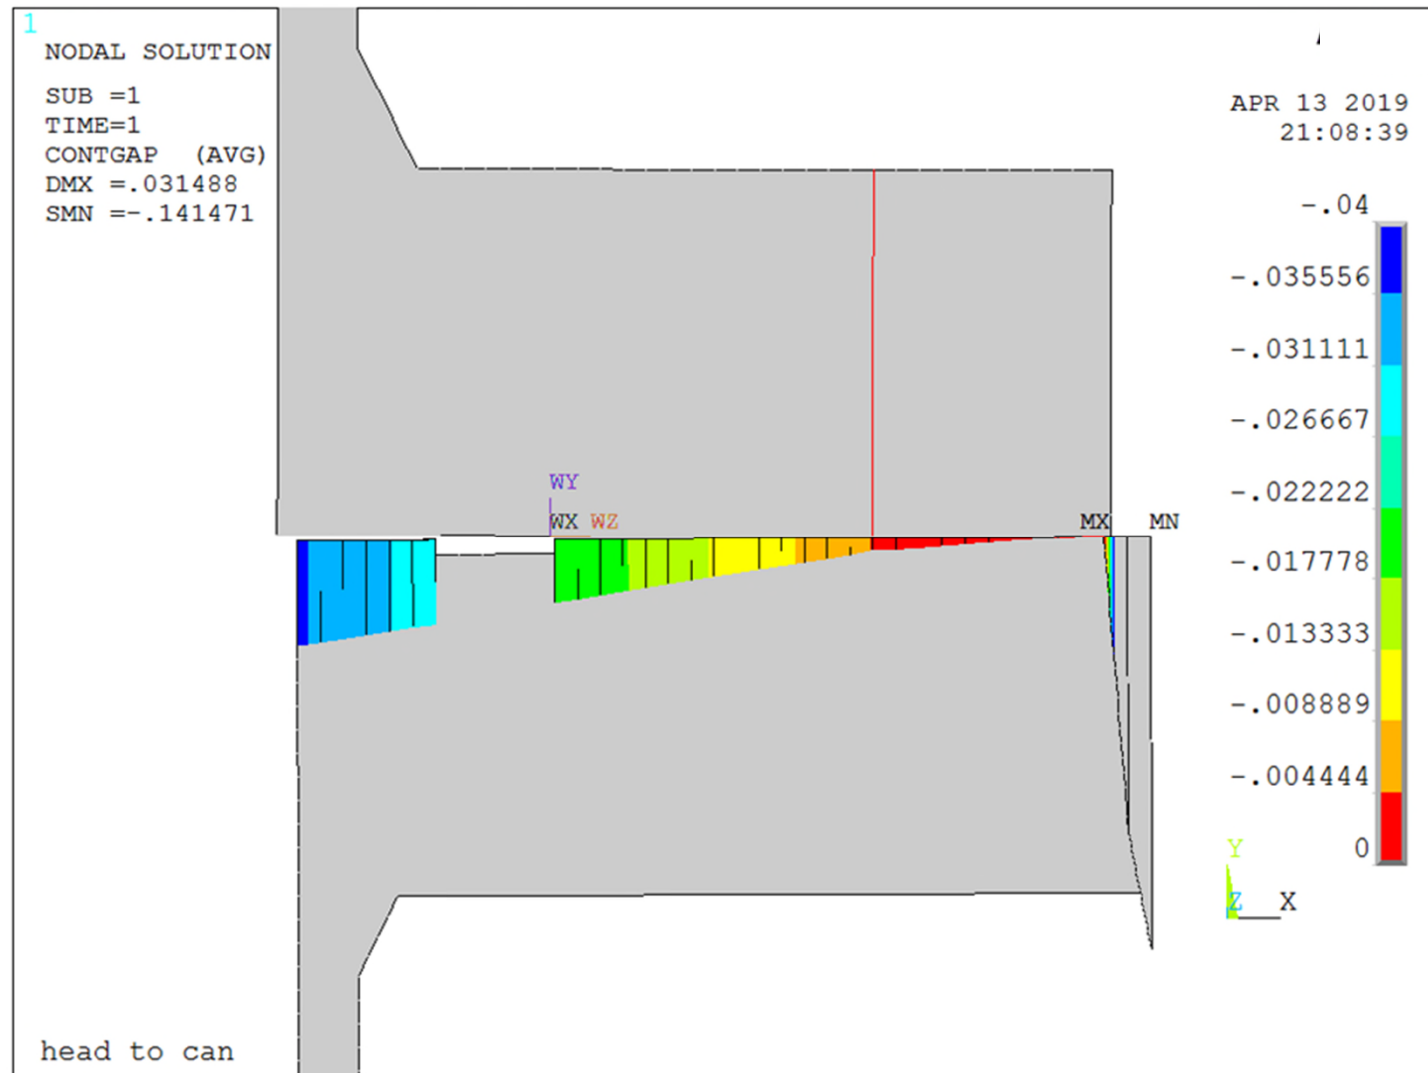
FEA of Flat Face Design

Flat Face with Spiral Wound.

Problem: Still too much gap / not adequately compressing the spiral wound gasket.

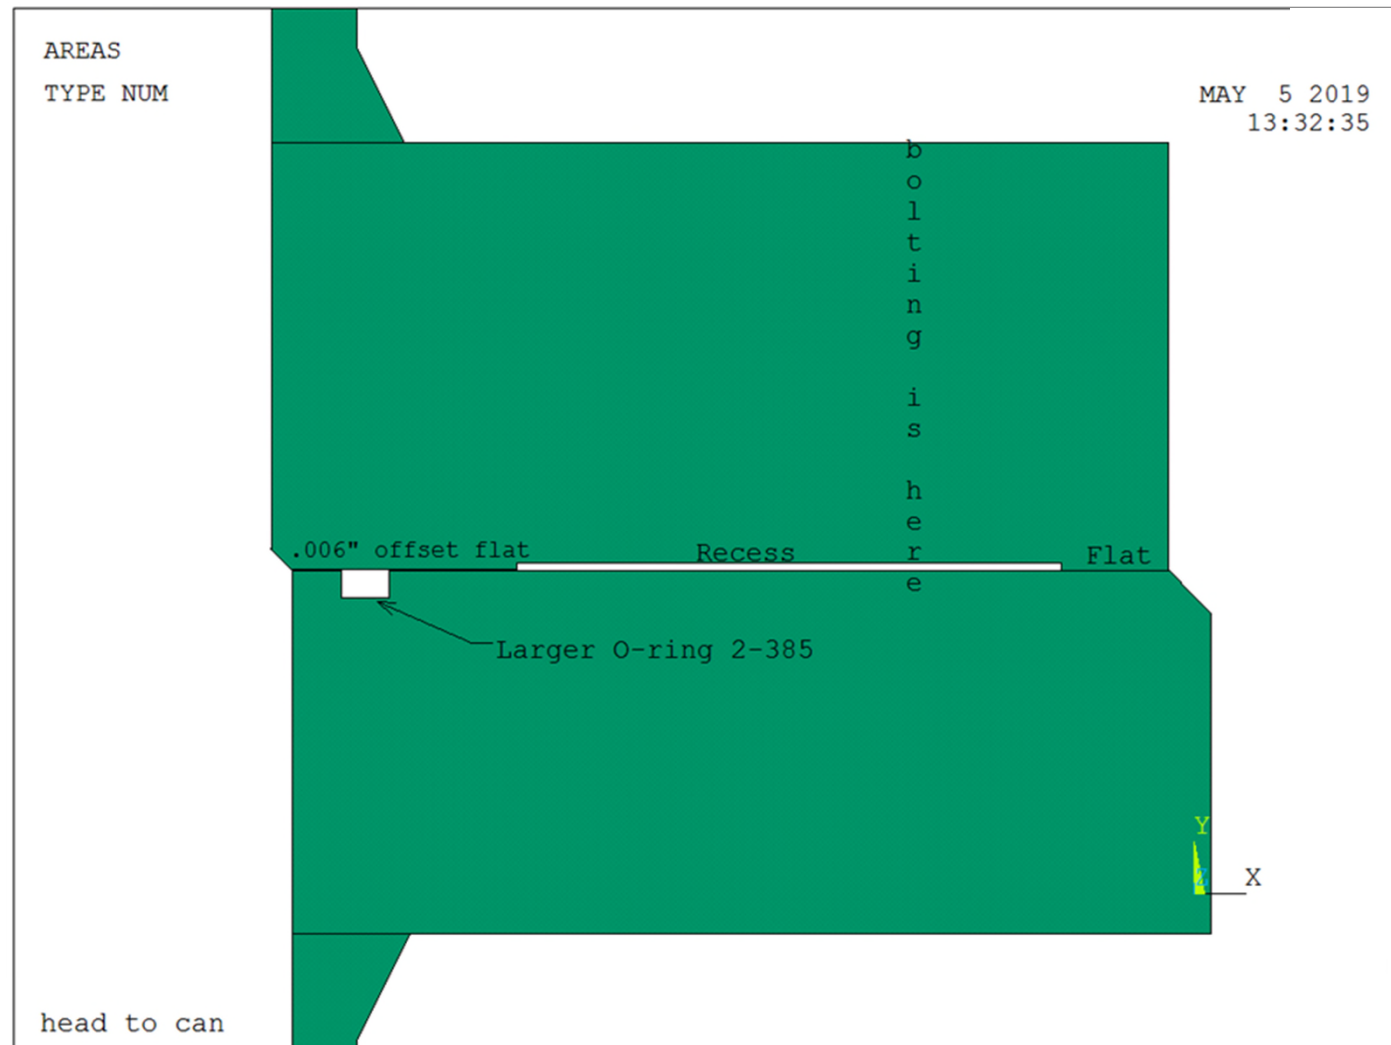
New Joint Profile

A New Profile is tried.

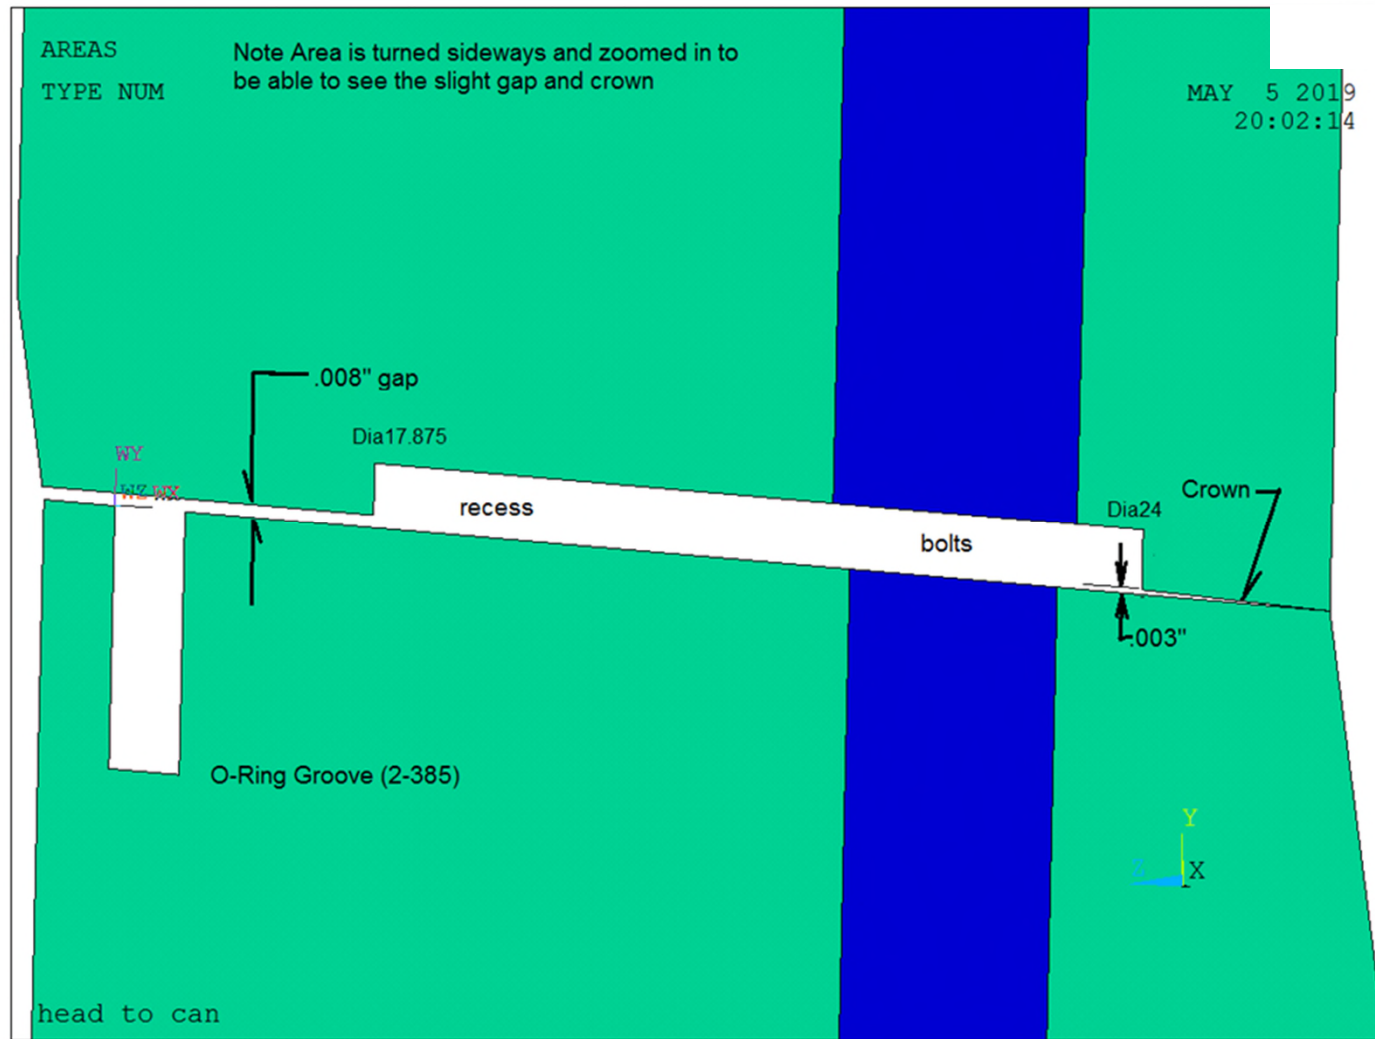
New Joint Profile

New Profile –
Final fine-tuned
Profile.

But by only re-profiling one flange surface,
We were able to pre-load at the O-Ring for zero
extrusion gap, thus a leak free joint.

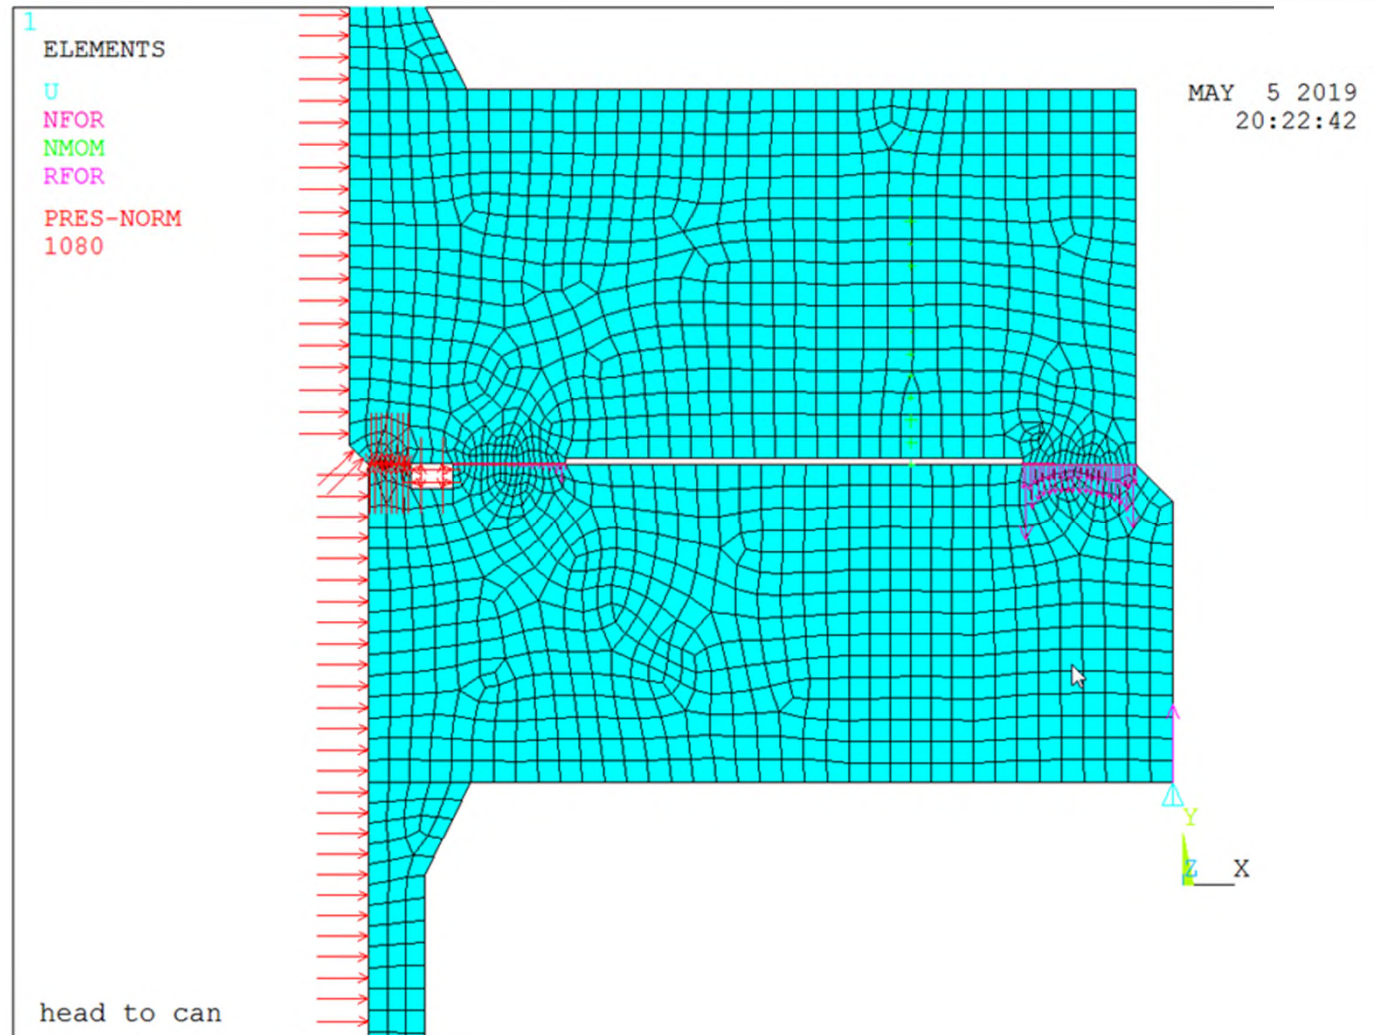
FEA Mesh

Hydrotest 1080
psi applied.

Bolt Force \sim 75%
of YS.

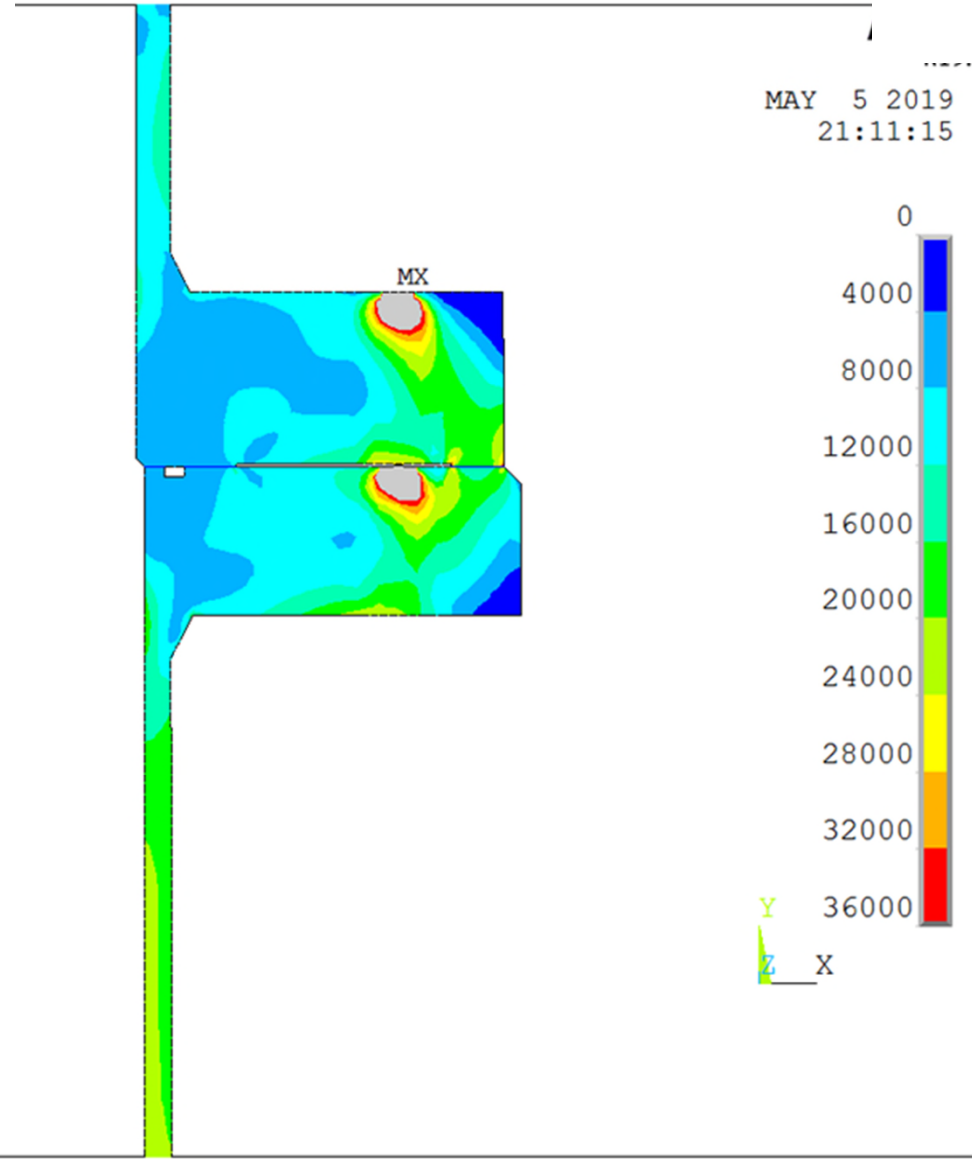
FEA of New Design

Von Mises Stress

(looks good)

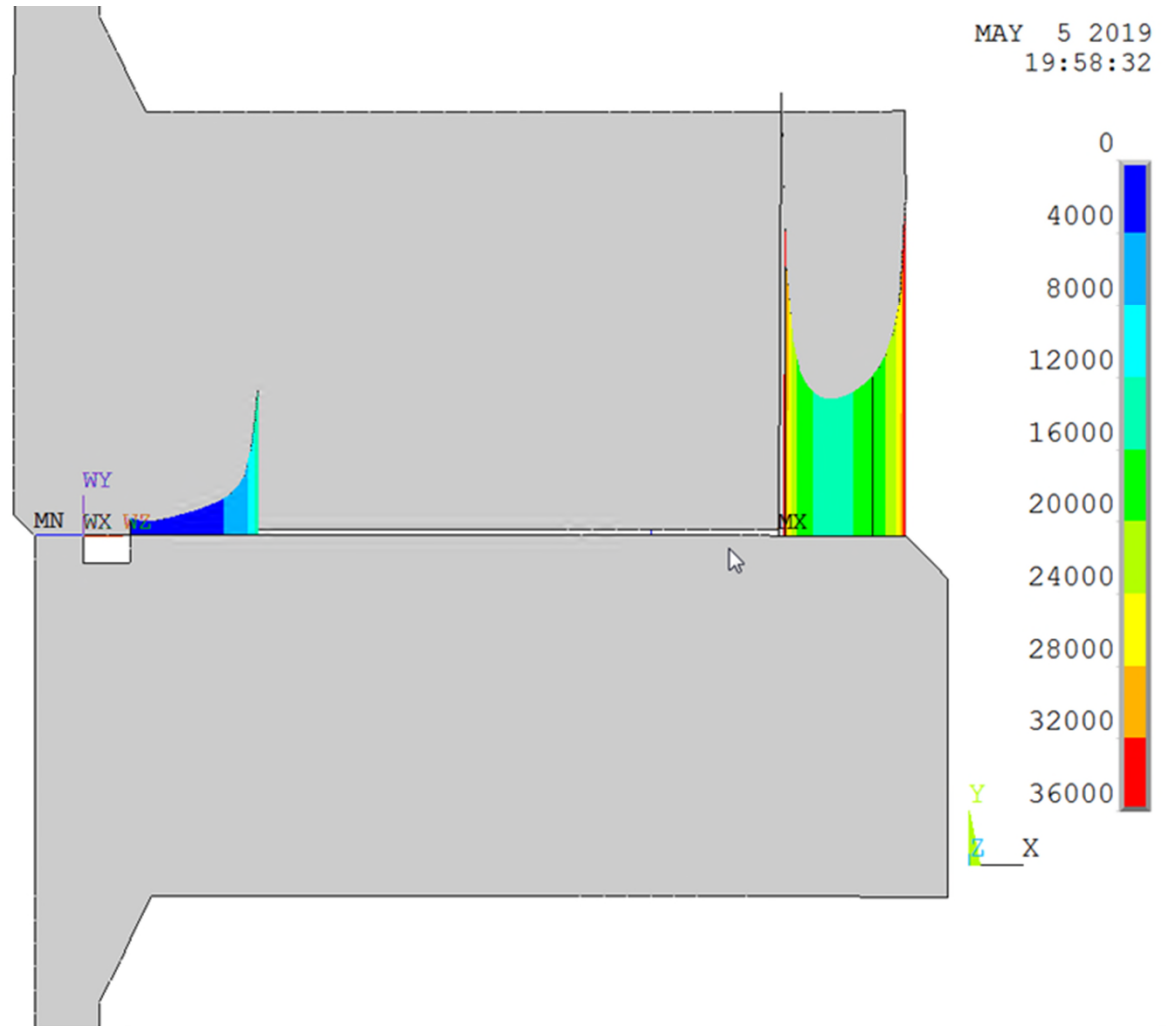
FEA of New Design

Results:
Contact Pressure

(Looks good: there is still contact pressure to the right of the O-ring).

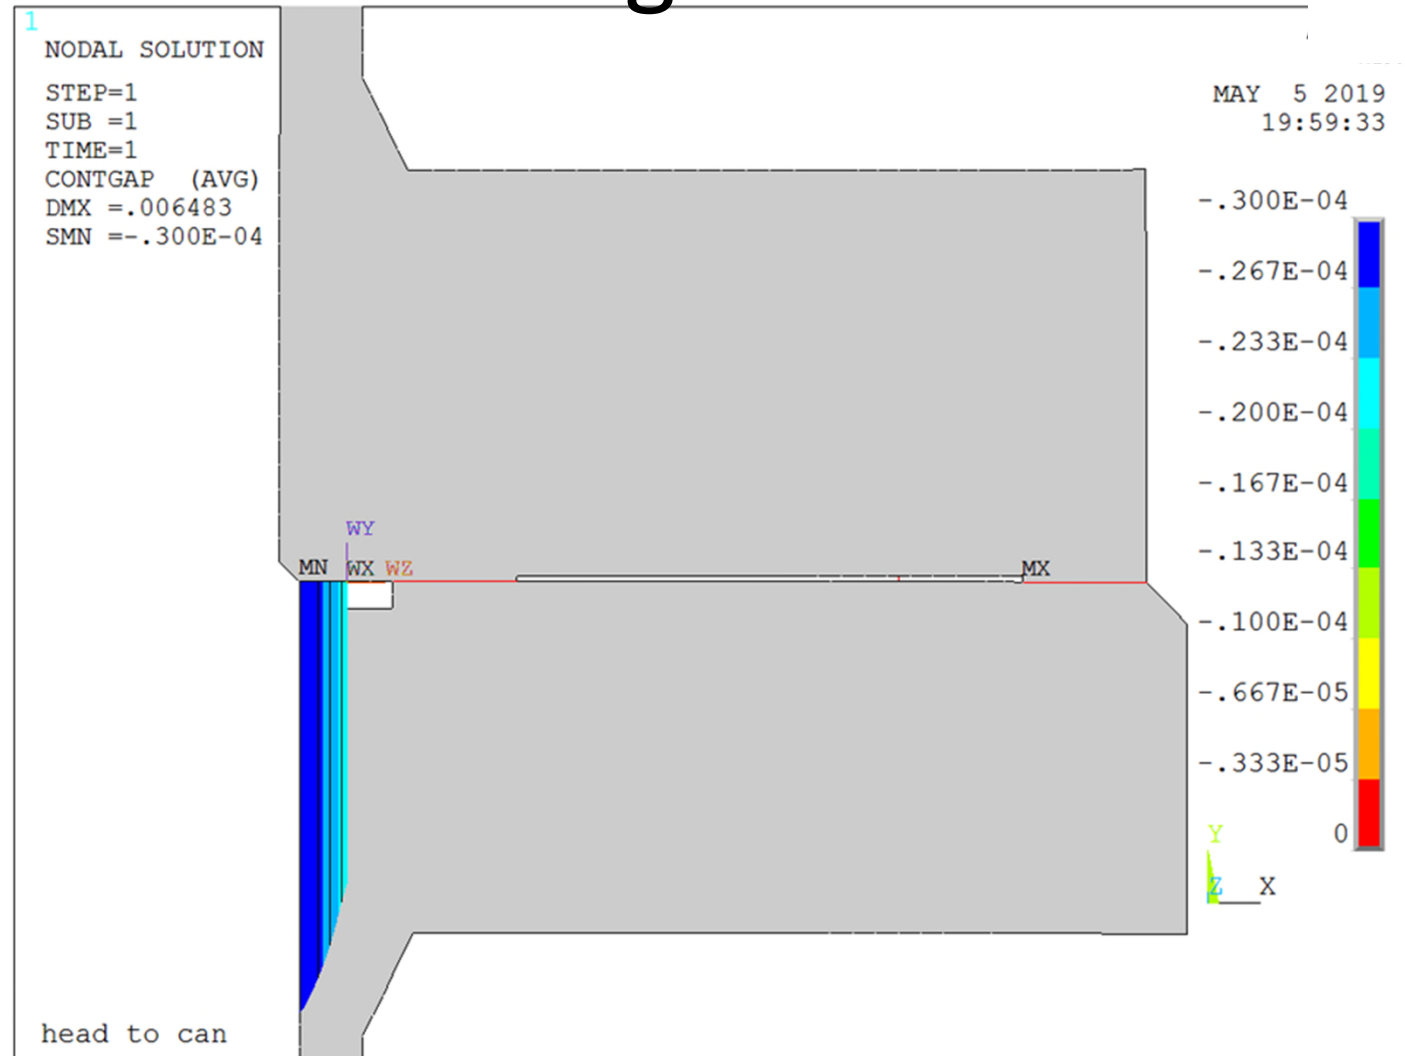
FEA of the New Design

Results: Contact Gap.

Extrusion Gap is now Zero .
