ASIA TURBOMACHINERY & PUMP SYMPOSIUM
23-26 FEBRUARY 2021
SHORT COURSES: 22 FEBRUARY 2021

STRATEGIES TO PREVENT SUDDEN CATASTROPHIC COMPRESSOR FAILURES DURING TRANSIENT OPERATING CONDITIONS

CASE STUDY 1: COMPRESSOR FAILURE DURING START-UP

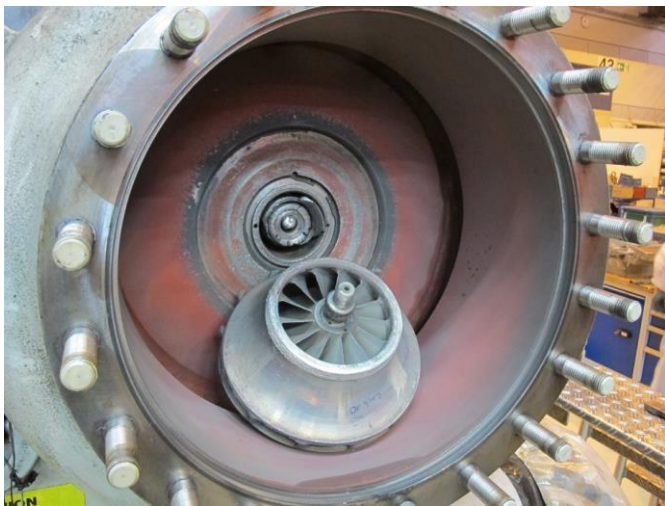
Figure 2: Damage Impeller

The damage to the compressor was extensive. The pinion shafts were all snapped off behind the impellers due to hard rubs, apart from the stage two impeller which had not rubbed. One of the damaged impellers is shown in Figure 2.

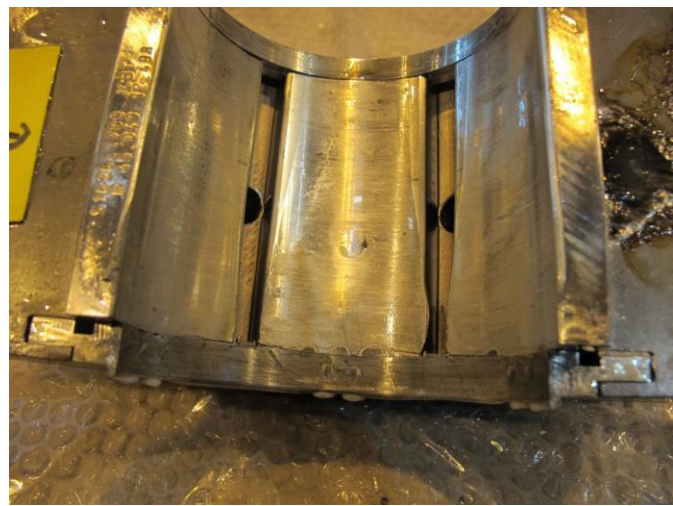
Figure 3: Damaged Pinion Bearing

The stage one/two tilting pad pinion bearings are a higher rated design than the other pinion bearings and showed little to no damage. The stage three/four and stage five/six pinion bearings were heavily damaged. An example of the damage is shown in Figure 3. These bearings consist of five pads. The pads are made from steel with a thin Babbitt layer on the inside diameter. It can be seen that the Babbitt was displaced due to very high loads and not wiped due to high temperatures.

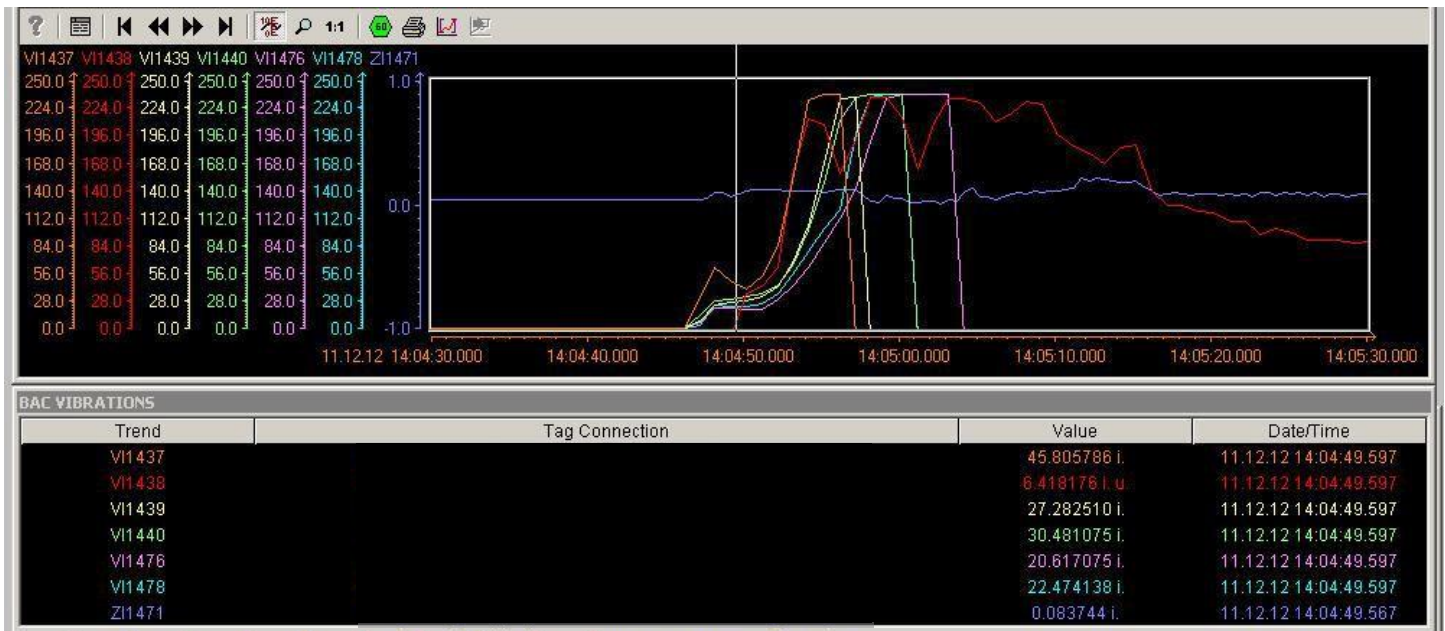
Figure 5: Start-Up Vibration Trends During Failure

Figure 4 shows the vibration trends during the start-up prior to the failure. Figure 5 shows the vibration trends during the start-up when the failure occurred. Comparing the trends, the vibration levels for the start-up when the failure occurred were higher from the moment the compressor was started. And, about five seconds into the start, the vibration levels for stages one and two increased exponentially to 250 microns p-p, which is the full range of the transmitters. The vibration levels for stages three and four also increased exponentially to 250 microns p-p, but lagged behind the stage one and two vibration increase by approximately two seconds. The vibration levels for stages five and six showed the same trend, but lagged two seconds behind the stage three and four increase. Note that some of the vibration readings drop sharply before the machine trip. This is because these vibration signals went to bad quality. The compressor did not trip on high vibration because the vibration shutdowns were bypassed for 30 seconds during start-up.

A review of the process trends during the start-up when the failure occurred did not show anything unusual at first. The machine discharge pressure rose continuously for about 15 seconds, but then suddenly dropped off. The stage inlet temperature trends also appeared consistent with past start-up trends for about 14 seconds, but then the inlet temperatures of stages three, four, five and six rose faster, particularly stage three.

For this compressor, several potential causes for the failure were reviewed. Although there is no direct evidence, it was surmised that the short time the auxiliary oil pump was run prior to start-up was a major contributing factor to the failure. Compared to the previous start-up, the bearing temperature readings had not stabilized, leading to the conclusion that the rotating and stationary parts had not reached thermal equilibrium. The differential temperatures in the rotors, bearings and casing could have been significant enough to cause distortion and lead to hard rubs in the seal areas or impeller running fits which could have caused the failure. This was addressed by incorporating a mandatory longer run time for the auxiliary oil pump before starting the compressor.

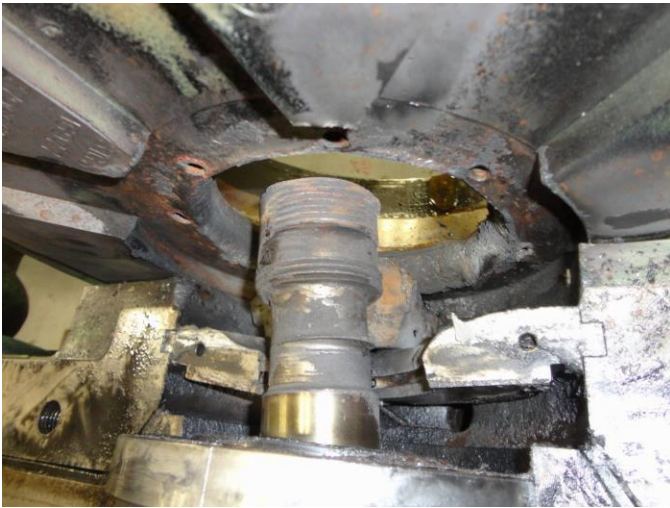
Figure 7: Damaged Pinion

Figure 7 shows a damaged pinion where it can be seen that the shaft end that drives the impeller was snapped off. Figure 8 shows damage to the normally unloaded bullgear thrust bearing. This will be discussed in more detail below.

It was concluded that the compressor failure was most likely a result of a sudden hard seal and/or impeller rub in the fifth stage followed by catastrophic secondary damage to stages one, two, three, four and six. All or some of the following issues most likely caused and/or contributed to the failure:

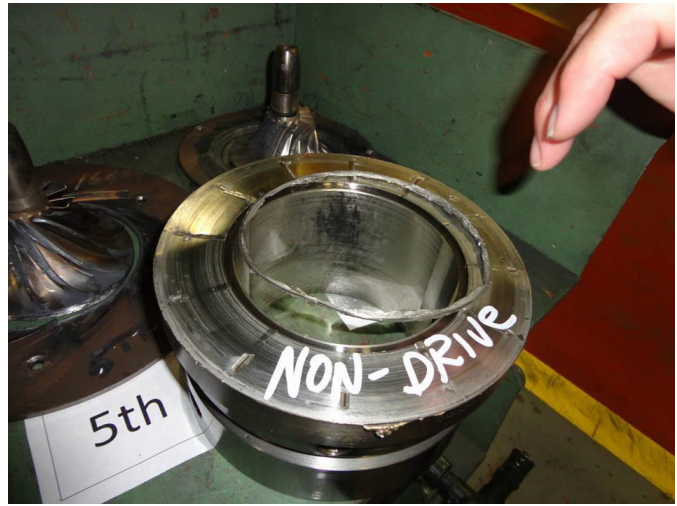
Figure 8: Normally Unloaded Bullgear Thrust Bearing

Long term operating trends showed no signs of progressive mechanical damage or wear. There were no detectable changes in long term vibration trends or thermodynamic performance. However, the bullgear thrust bearing damage was predominately on the non-drive end, which is opposite the calculated direction of thrust at the design operating conditions. Thus, it is likely this damage occurred during a transient event, such as a compressor shutdown, and not during normal steady state operation. Since there were limited shutdowns, this damage could have gone undetected. In this scenario, progressive damage could have occurred during each shutdown until there was sufficient wear/damage to allow for contact between rotating and stationary parts. The bullgear shaft is not fitted with an axial position probe and so it is not possible to determine exactly when the damage occurred.

As discussed above, it is also very plausible that the progressive bullgear thrust bearing wear was a result of repeated reverse rotation incidents that occurred when the machine was shut down. This could have been caught during commissioning and is a good learning experience. It really shows how important it is to have experienced, qualified people lead critical compressor commissioning activities and that they look at all aspects of the machine operation.

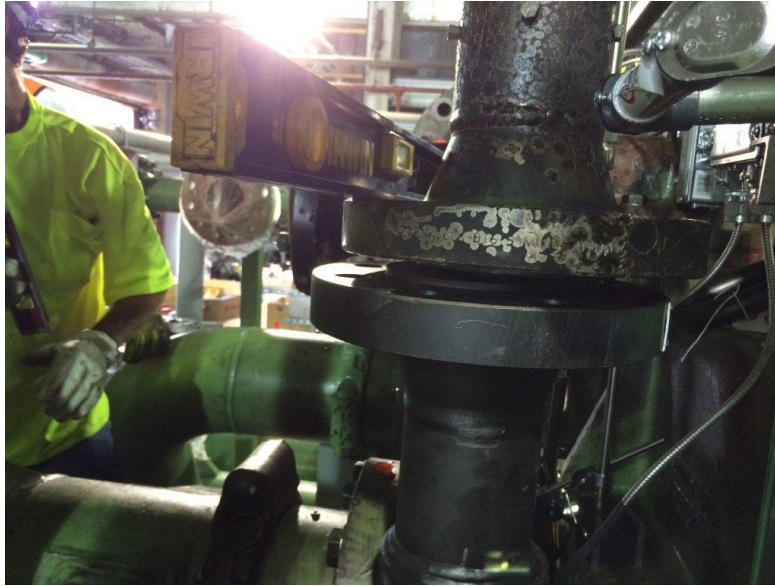
Figure 9: Piping Misalignment

The millwrights that removed the compressor after the failure reported a difficult time removing some of the piping due to excessive misalignment. During reassembly at site after the repair, numerous interstage pipes had to be modified in order to correct this piping misalignment. A picture showing some of the gross piping misalignment is shown in Figure 9. It was concluded that gearbox distortion resulting from excessive piping misalignment could have contributed to the failure by resulting in reduced impeller to shroud running clearances and/or bearing and seal misalignment.

- Reduced operating clearances due to excessive gearbox distortion caused by excessive pipe strain
- Non-drive end bullgear thrust bearing wear/damage during repeated shutdown reverse rotation incidents
- Non-drive end bullgear thrust bearing wear due to gearbox distortion

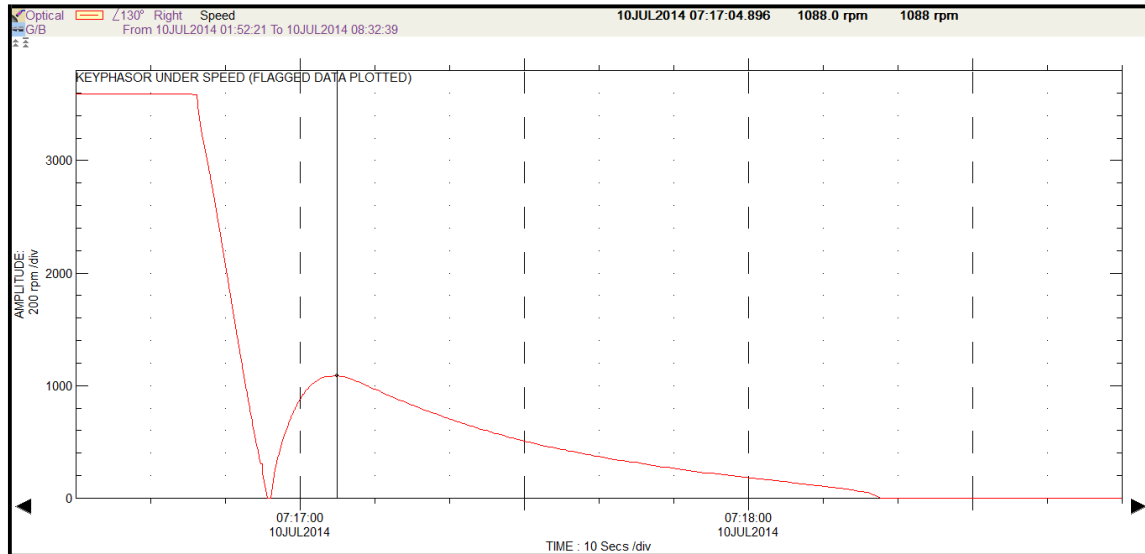
Figure 10: Speed Verses Time Shutdown Trend

A review of the data at the time of the failure did not show any evidence of reverse rotation on the compressor shutdown. After the repair, the compressor went through extensive testing at site. Following the first full load shutdown test it was observed that the compressor stopped rotating about 10 seconds after being tripped and then spun backwards for about one and a half minutes, reaching a reverse speed of about 1000 RPM. This was seen by a GE-BN vibration analyzer that was being used for detailed vibration testing following the repair. See Figure 10. Operating in reverse is something that should be prevented because of potential for damage/wear due to lubrication problems, possible over pressure of oil pump suction piping, damage to oil pump foot valves and possible damage to bearings. The bullgear tapered land thrust bearings in this machine are a unidirectional design and have significantly reduced load carrying capability when operating in the reverse direction. If the normally unloaded bullgear thrust bearing was damaged due to repeated reverse rotation incidents, this could have contributed to the compressor failure.

On a compressor shutdown, the recycle valve opens to reduce the discharge pressure to prevent surge and reverse rotation. If the discharge pressure is not reduced quickly enough, the trapped gas can act like a brake, stopping the compressor and then reverse flowing until the suction and discharge pressures equalize. High reverse flow through the compressor can cause the compressor to rotate in reverse and act like an expander. To prevent this from occurring, the recycle valve needs to be sized to handle the required flow, the recycle valve needs to open quickly, a check valve needs to be installed downstream of the compressor discharge and the discharge piping volume needs to be minimized. To address this for this compressor, the recycle valve opening time was reduced as much as possible and a discharge dump valve was added. The dump valve opens on a compressor shutdown to vent high pressure discharge gas to atmosphere. There are no permit implications from venting in this particular application.

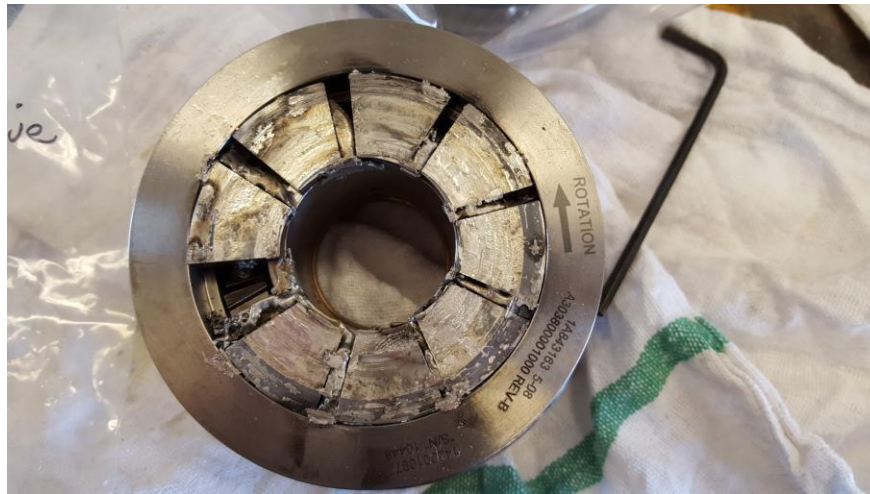
Figure 15: Pinion 2 Inactive Thrust Bearing Damage

Figure 15 shows a picture of the damaged first stage inactive thrust bearing.

The other possibility is that a high reverse flow through the compressor could cause the machine to stop quickly and then rotate in the reverse direction. There is no data to substantiate this, but the rotor one inactive thrust bearing damage seemed to be consistent with reverse rotation based on the pattern of the Babbitt smearing. Although the damage evidence isn't conclusive, it suggests the possibility. This is significant because the pinion thrust bearings are a unidirectional design. Allowable bearing load in the reverse direction of rotation is substantially less and is even lower at lower speeds.

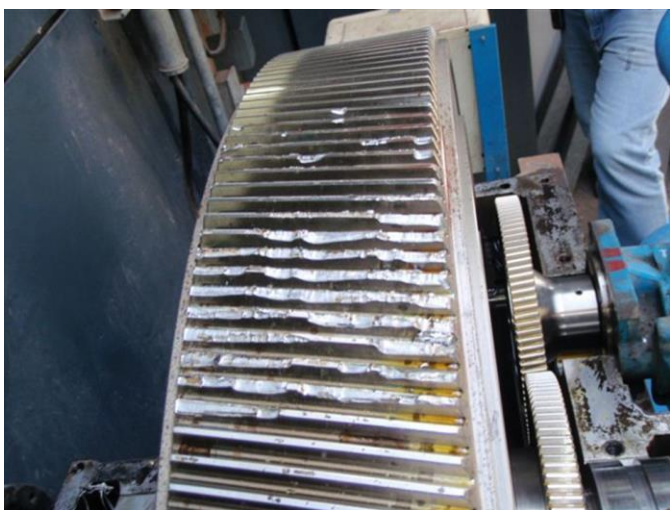
Figure 19: Gear Damage

The damage to the compressor and gearbox was extensive. The labyrinth seals and seal bushings in both compressors were badly rubbed and had to be replaced. The bullgear and pinion teeth had also failed. See Figure 19. And the couplings between the gearbox and high pressure compressor and between the high pressure compressor and low pressure compressor were twisted and bent. It was clear that this was a very violent failure.

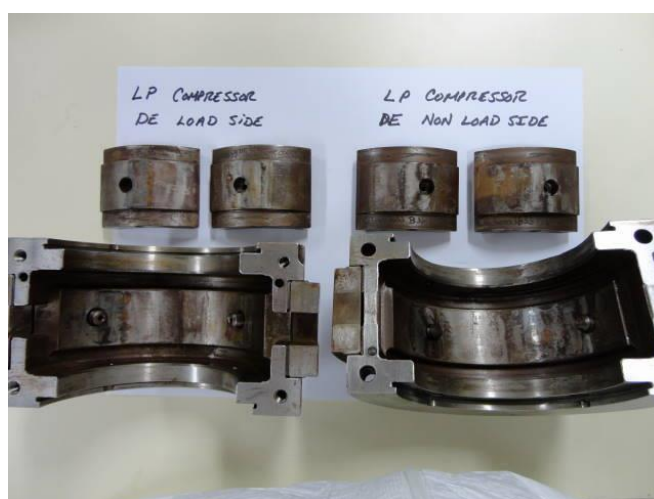
Figure 20: Bearing Damage

One of the most interesting finds was with the four compressor bearings. These are tilting pad type bearings. The pads are made from steel with a thin Babbitt layer on the inside diameter. The bearing Babbitt surfaces were found to be in good condition, especially considering the years in service. There were no indications of Babbitt fatigue, scoring or wiping and no signs of oil varnishing or problems associated with oil contamination, oil oxidation or excessive heat. However, wear and contact damage was noted on the oil retaining ring (oil dam). This was rather surprising given that the oil retaining ring clearance by design is greater than journal clearance. From these inspections it was clear that the shaft had come into hard contact with the oil dam despite no significant wear of the Babbitted surfaces. When the bearings were disassembled, severe wear and fretting damage was found on the back of the pads at the pivot points and on the corresponding bearing housing bore surfaces. See Figure 20. This extreme wear and fretting damage caused flat spots at the pivot locations which inhibited the rocking action of the pads. The wear also resulted in significant increases in bearing clearances. For example, the as found low pressure compressor non-drive end (NDE) bearing clearance was .025 inches versus a design maximum of .007 inches. It is unlikely that the wear occurred at the time of the failure. The damage was more consistent with long term, progressive wear. What is real surprising is, that despite this notable bearing damage, there was no significant increase in compressor vibrations during steady state operation.

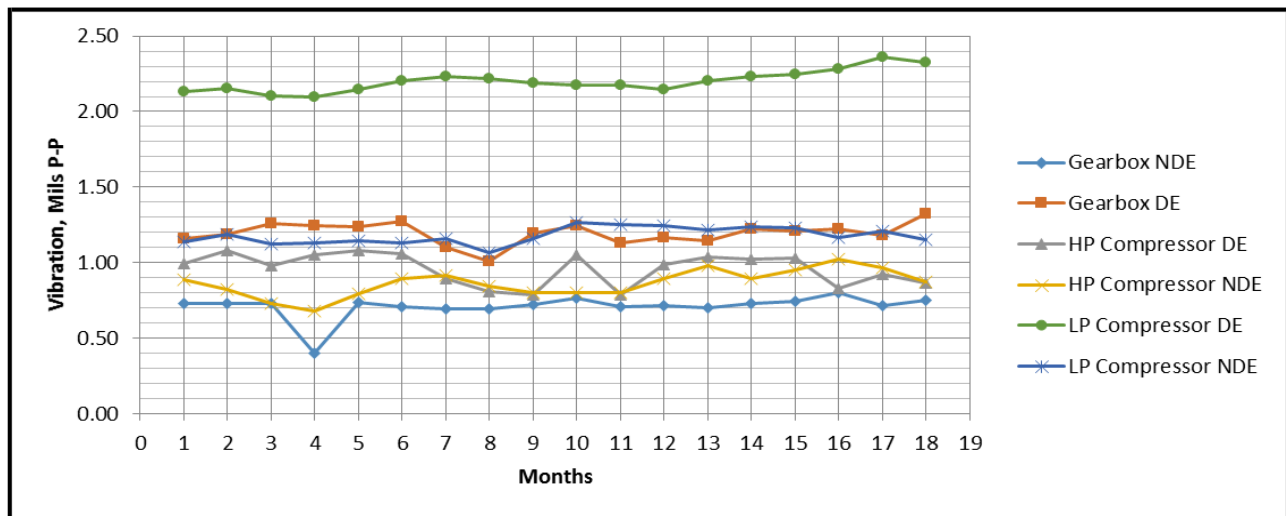
Figure 21: Vibration Trends

As mentioned previously, the compressor mechanical and thermodynamic performance was reviewed monthly and the efficiency, rotor vibrations and bearing temperatures were stable. A plot of 18 months of vibration data leading up to the failure is shown in Figure 21. The low pressure compressor DE vibration was somewhat high, but it appeared stable and was below the alarm point. A more detailed review showed that this vibration had slowly gone up almost one mil in vibration since commissioning (13 years later). And although the vibration appeared stable, it had been approaching the alarm limit. Other than this vibration point, all other compressor and gearbox vibrations were significantly lower than the alarm set points.

On this machine the vibration protection is bypassed for 30 seconds during start-up. The vibration bypass allows for the rotors to accelerate through the shaft critical speeds on start-up without shutting down on high vibration. After the failure the start-up vibration trends from some of the recent successful start-ups were reviewed. Other than moderately higher pinion non-drive end (NDE) bearing vibration, none of the other compressor or gearbox vibration trends were different from previous start-ups. However, start-up trends were not saved or reviewed and only recent start-up data could be obtained. It's not certain if the start-up vibration levels changed significantly through the years of operation.
