A New Bolted Joint Profile, Optimized with FEA, Fixes a Leaking Propane Pump.

John M Schmidt, PE, Oregon

The Issue.

A Vertical Pump (VS6) in Propane loading service (installed 1978) at a Petroleum Refinery.

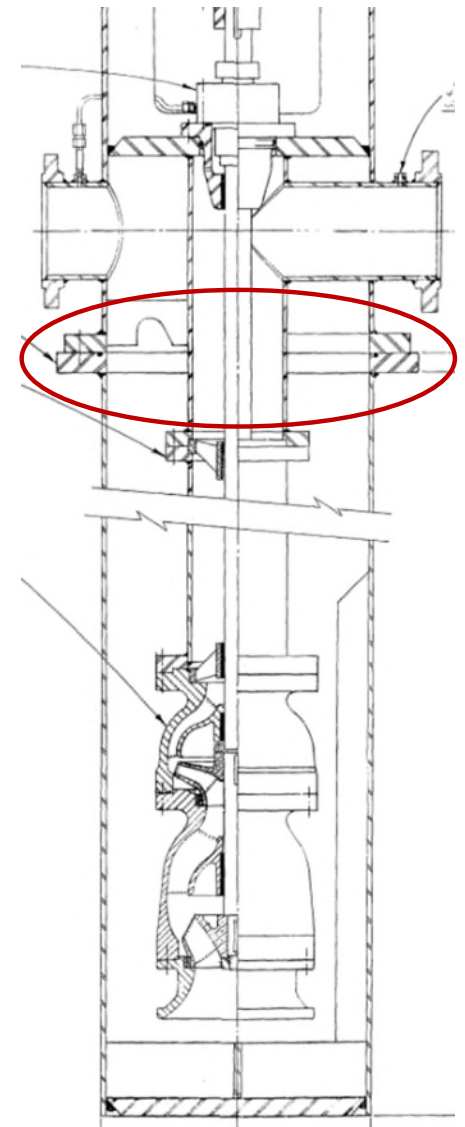
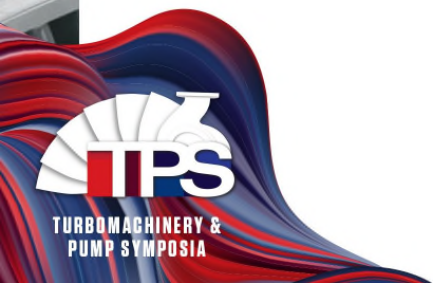
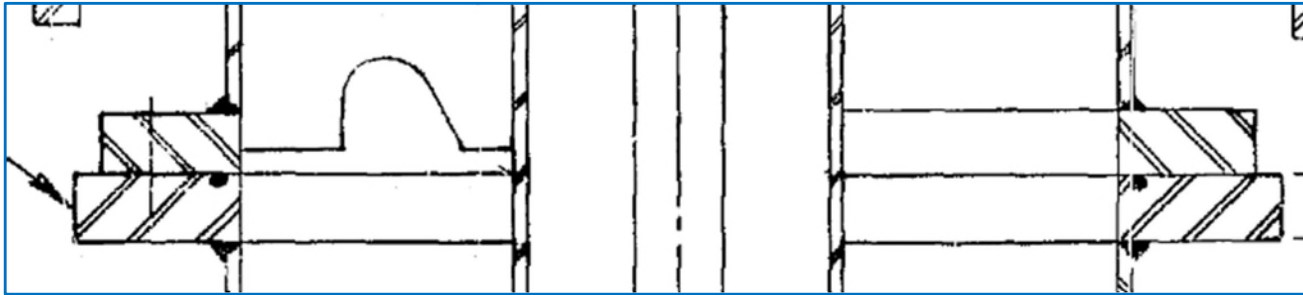
The original design

Upon further inquiry, the reason for the requested upgrade was because the current raised faced joint (with an O-ring) would occasionally leak.

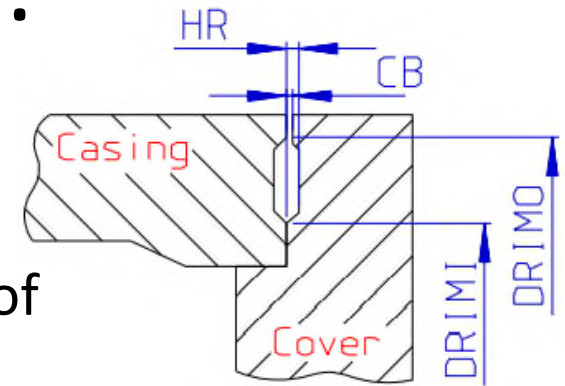
New Joint Profile

-A conference call with customer determined that they didn't specifically need a Spiral Wound gasket, just a joint that didn't leak.

-Went back to an O-ring since it is self energizing.(It doesn't need as much bolt force).

A New Profile is tried.
