ASIA TURBOMACHINERY & PUMP SYMPOSIUM
23-26 FEBRUARY 2021
SHORT COURSES: 22 FEBRUARY 2021

STRATEGIES TO PREVENT SUDDEN CATASTROPHIC COMPRESSOR FAILURES DURING TRANSIENT OPERATING CONDITIONS

CASE STUDY 1: COMPRESSOR FAILURE DURING START-UP

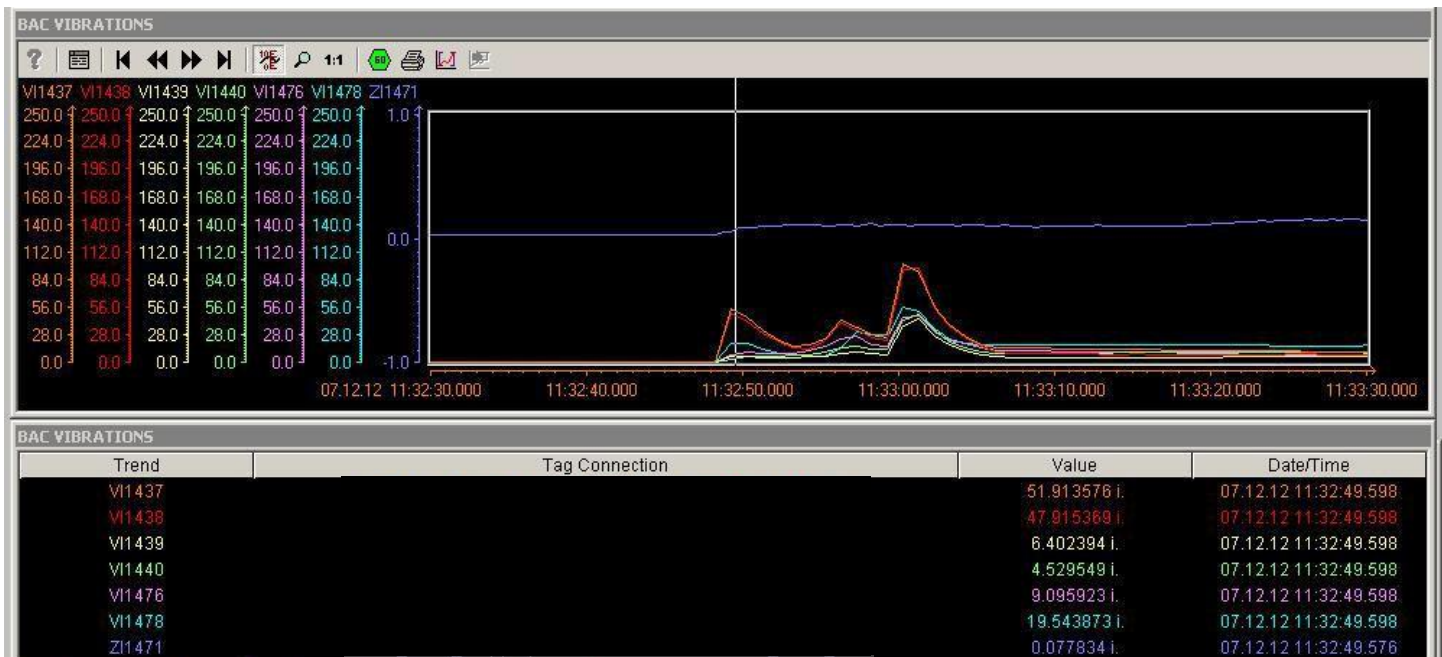
Figure 4: Normal Start-Up Vibration Trends

Based on prior starts, the compressor reaches full speed in about 17 to 18 seconds. As shown in Figure 4, on the start-up prior to the failure, the vibration of all the stages spikes just before reaching full speed. It was determined that this was due to excitation from the train torsional natural frequency (TNF). The calculated TNF is 1250 CPM, which is 83% of the operating speed of 1500 RPM. A field test performed later confirmed the TNF. It was determined that the radial vibration response when the compressor accelerates through the torsional critical speed was normal and not a problem.

As shown in Figure 4, the vibration levels for some stages on this machine spike momentarily during the start-up as the particular rotor accelerates through a resonant frequency. And, as noted above, the vibration on all stages spikes when the compressor accelerates through the train torsional natural frequency. The high vibration trip set points are set at values that are lower than some of these vibration spikes because the high vibration trip set points are based on operation at the normal operating speed. To prevent the machine from tripping during start-up, the control system was configured to automatically bypass the high vibration trips for 30 seconds. Although this is a common method to manage vibration spikes during start-up, it also eliminates the vibration protection for this period of time.

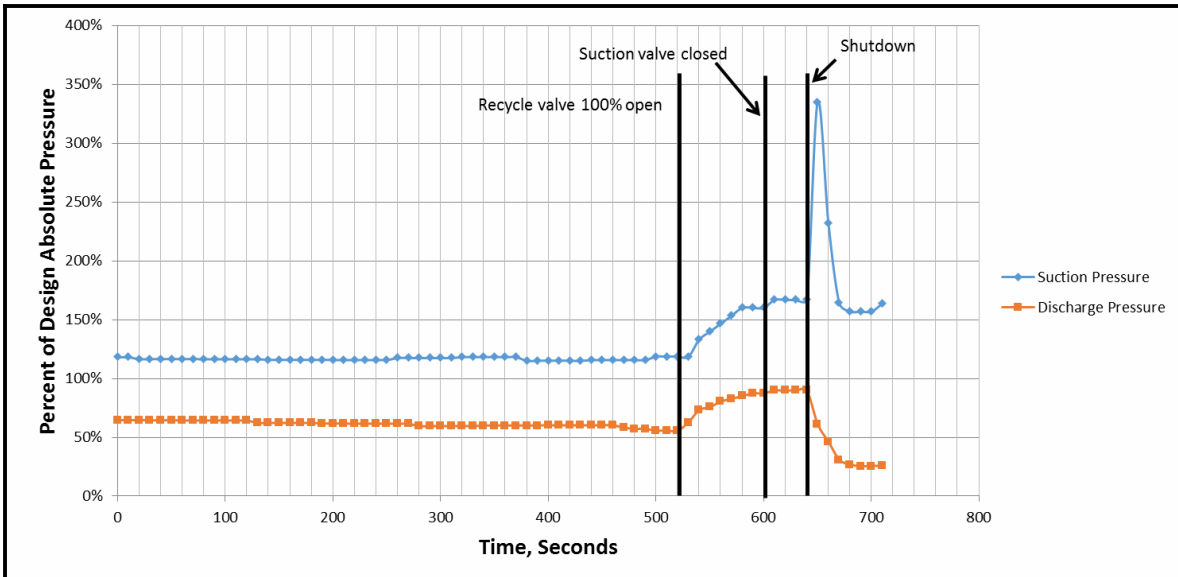
Figure 13: Pressure Trends

The compressor ran well for the next five years until there was an upset condition in the industrial gas plant which resulted in a loss of the heat load. The MR system was kept in operation to avoid a shutdown and restart. However, the loss of the heat load caused changes in the MR system operating conditions. Initially there was a significant drop in the system pressures and temperatures as more MR was condensed in the heat exchanger due to the loss of the heat load. With the control valves being operated in manual, the expansion valve was further opened. This brought back the compressor suction pressure and system temperatures, but the discharge pressure was still lower than design. This resulted in the compressor operating near the stonewall condition, which was a concern based on the previous failure. The expansion valve was then pinched back while the compressor recycle valve was slowly opened in an attempt to increase the pressure ratio while maintaining reasonable system pressures and temperatures. But these changes caused the compressor suction pressure to slowly rise and stabilize at a higher pressure than design, while the discharge pressure and system temperatures slowly dropped. Once the recycle valve was completely open, the compressor suction pressure and machine power increased very rapidly. In a little over a minute the suction pressure went from 115 percent of design to 160 percent of design. The suction valve was then closed, but this didn't lower the suction pressure or machine power and the operator tripped the machine. After the shutdown, the suction pressure momentarily spiked to over 300 percent of design before the system settled out at about 150 percent of design suction pressure. Trends of suction and discharge pressure for the last ten minutes of operation are shown in Figure 13. After the machine was shut down, there were significant changes in the stage one and two rotor axial positions, which indicated possible thrust bearing damage. See Figure 14.

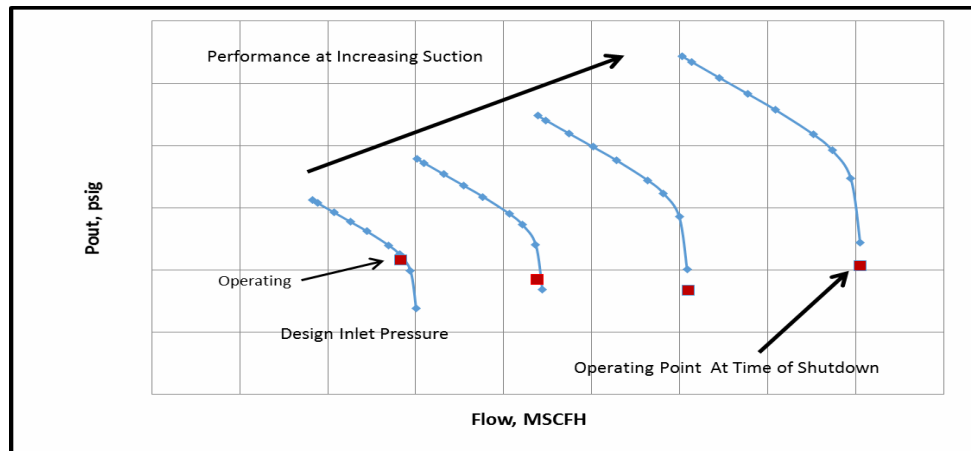
Figure 16: Compressor Performance During Event

After the initial drop in suction pressure, the suction pressure rose during the entire event. Using shop test data, a thermodynamic performance model was created to evaluate the overall operating conditions and interstage conditions leading up to the failure. As shown in Figure 16, the compressor was driven into a stonewall condition as the suction pressure rose. The interstage performance at different conditions had to be extrapolated from the shop test stage curves.

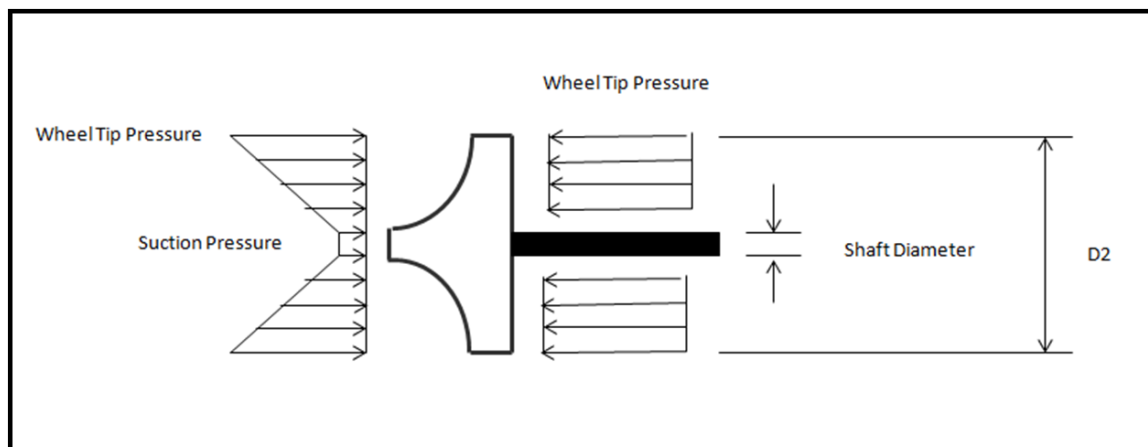
Figure 17: Pressure Forces Acting On Impeller

Figure 17 shows a simplified model of the pressure forces acting on the impeller. The pressure forces drive the rotors towards the impeller end at normal operating conditions. For rotors one and two, the gear reaction forces are opposite in direction to the impeller pressure forces. However, at the design point, the gear reaction forces are less than 50 percent of the pressure forces acting on the impeller, and so the net force is still towards the impeller. Note that for rotor three, the pressure force and gear reaction force are in the same direction at normal operating conditions. At the higher suction pressure conditions, there is a modest increase in the calculated net rotor one axial thrust force while the corresponding calculated axial thrust forces for rotors two and three drops. The rotor one thrust force is still well within design limits. And, as shown in Figure 14, the shift in axial position on all the rotors coincided with machine shutdown. So, it is unlikely that the first and second stage inactive thrust bearing damage occurred before the shutdown.

As the pressures in the compressor settle out, the pressure forces acting on the impellers will drive the rotors in the normally inactive direction, away from the impeller. As shown in Figure 17, the face area on the front side of the impeller is larger than the
